# Duignan Inspections

**Eva Rivera**  
**3652 W. 61st Pl.**  
**Chicago, Illinois 606**

## SUMMARY

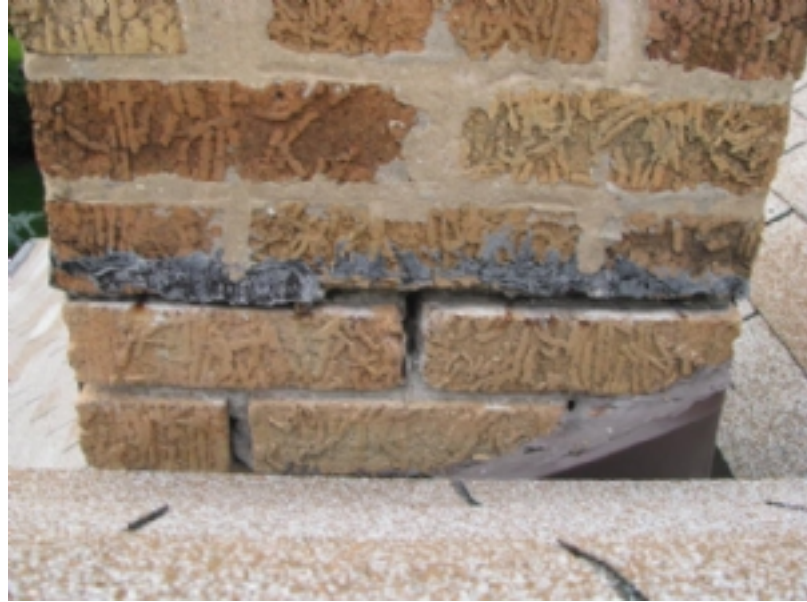
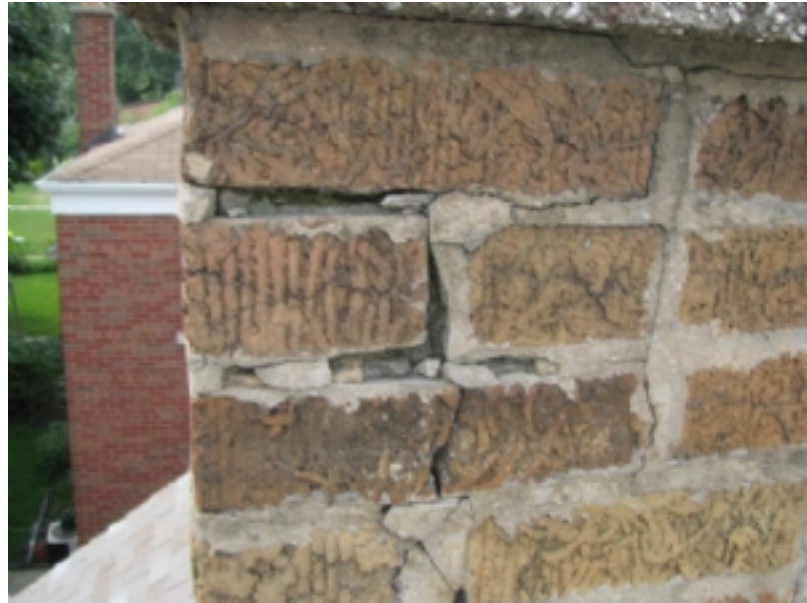
### Chimney:

**REPAIR or REPLACE** - Mortar is deteriorated. In my opinion this allows for water to enter building. Water leakage can cause various problems to the building and can cause damages to the chimney system. I recommend that you contact a qualified contractor such as a chimney sweep or mason for appropriate corrective action.

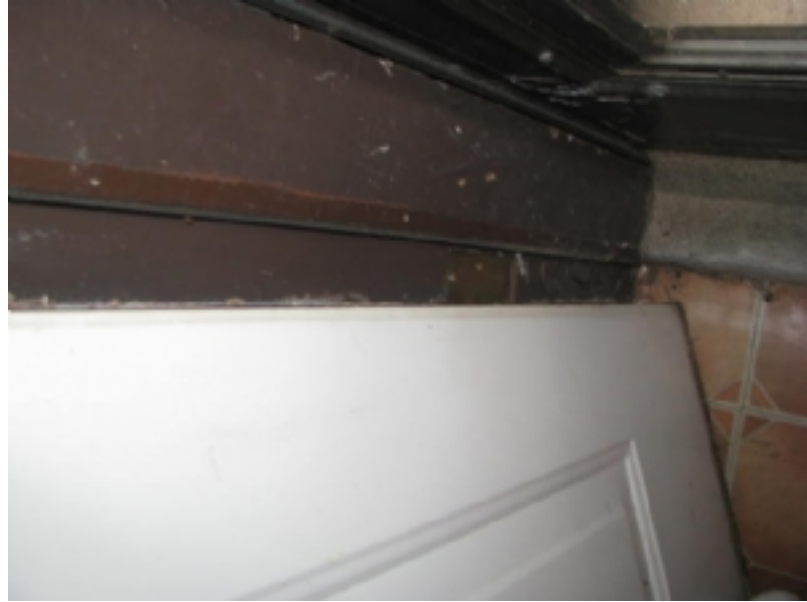
### Doors:

Basement door hinge is pulling from the jam.

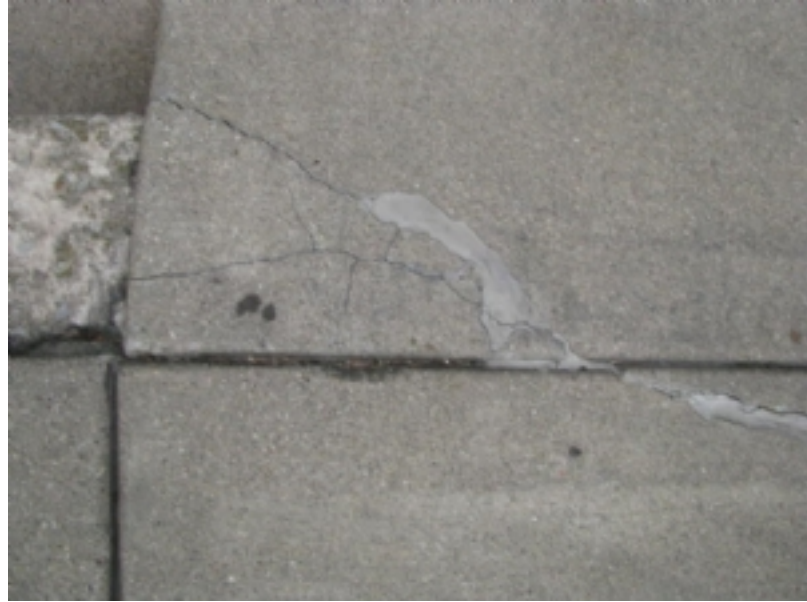
### Walkways:

**SAFETY** - Uneven walking surfaces are present on this property. In my opinion this is considered a trip hazard and can lead to injury if not corrected. I recommend that you contact a qualified contractor to correct this situation.

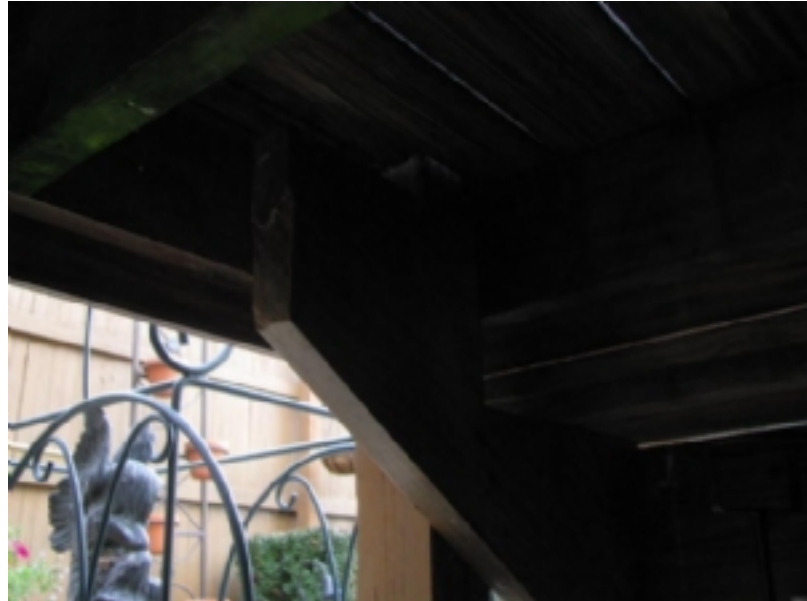
### Decks:

stair stringers detached from underside of deck

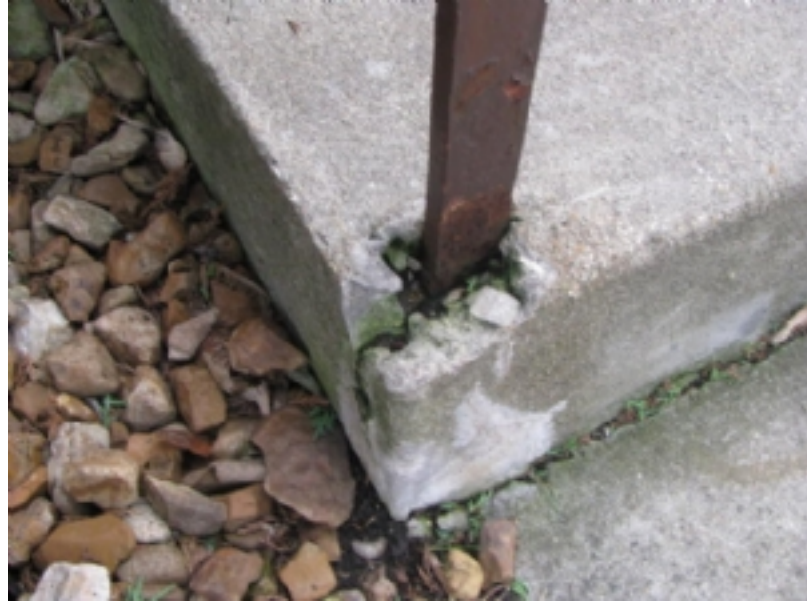
### Porches:

Concrete cracking at base of railing

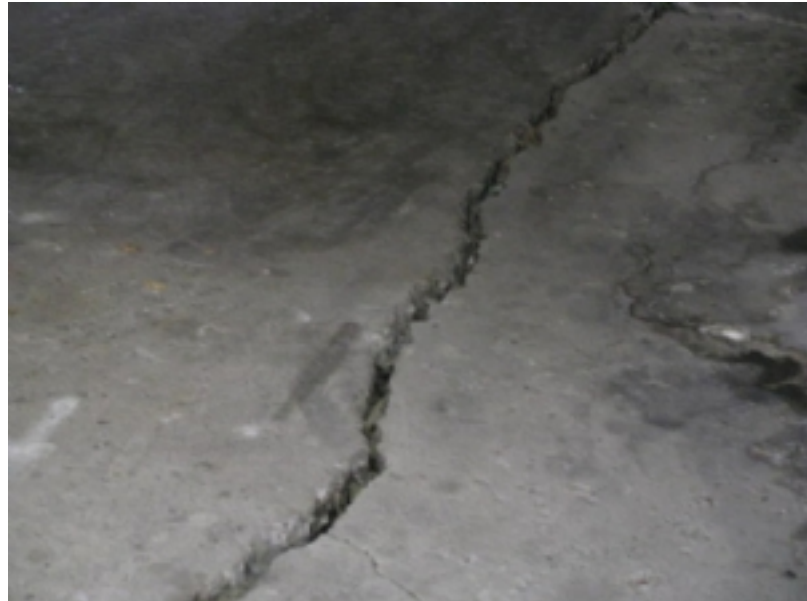
### Garage Floors:

**SAFETY** - Uneven walking surfaces are present on this property. In my opinion this is considered a trip hazard and can lead to injury if not corrected. I recommend that you contact a qualified contractor to correct this situation.

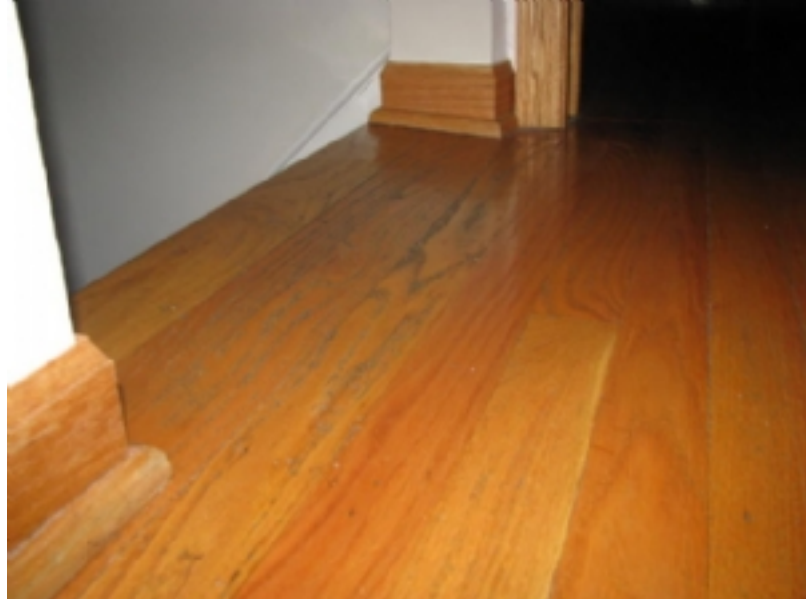
### Stairway:

**SAFETY** - Uneven walking surfaces are present on this property. In my opinion this is considered a trip hazard and can lead to injury if not corrected. I recommend that you contact a qualified contractor to correct this situation.

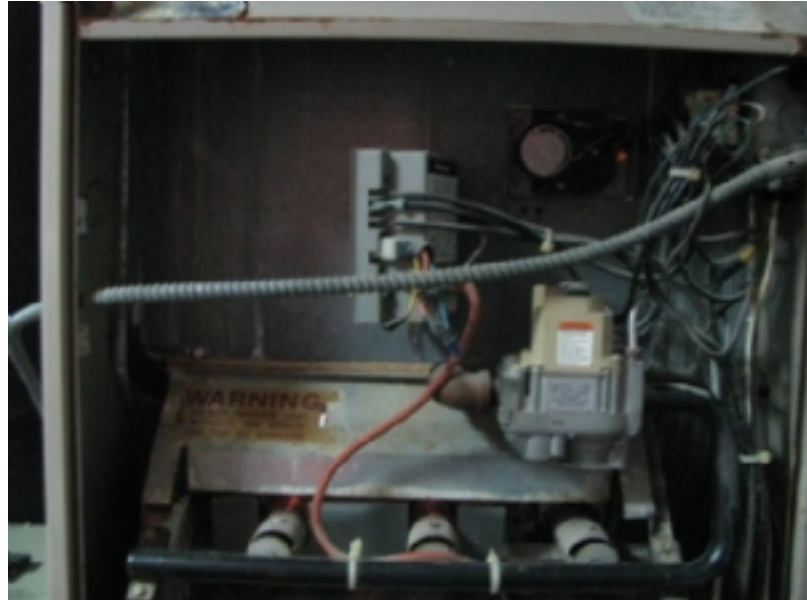
**Approximate Age:**

**REPLACEMENT:** Based on its age, it is my opinion that the heating system is at or beyond its useful life and should be replaced.

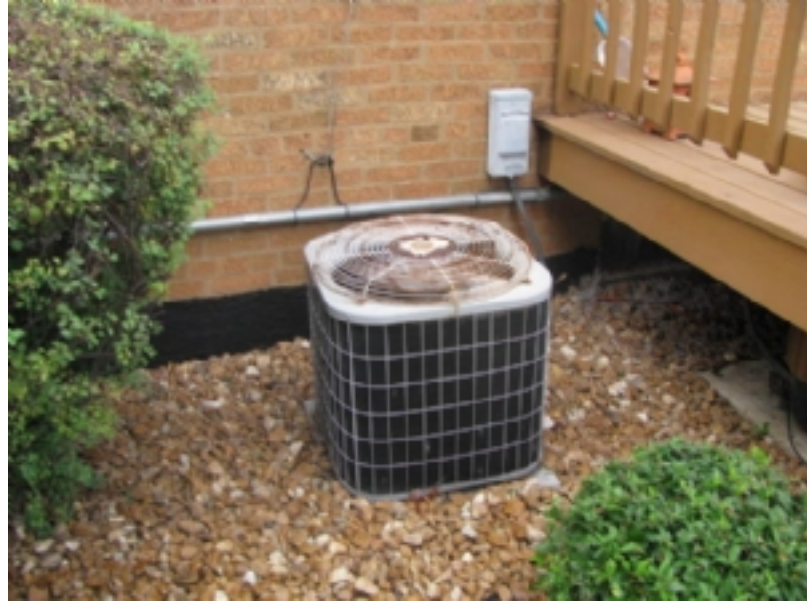
**Approximate Age:**

The unit is nearing the end of its expected life span.

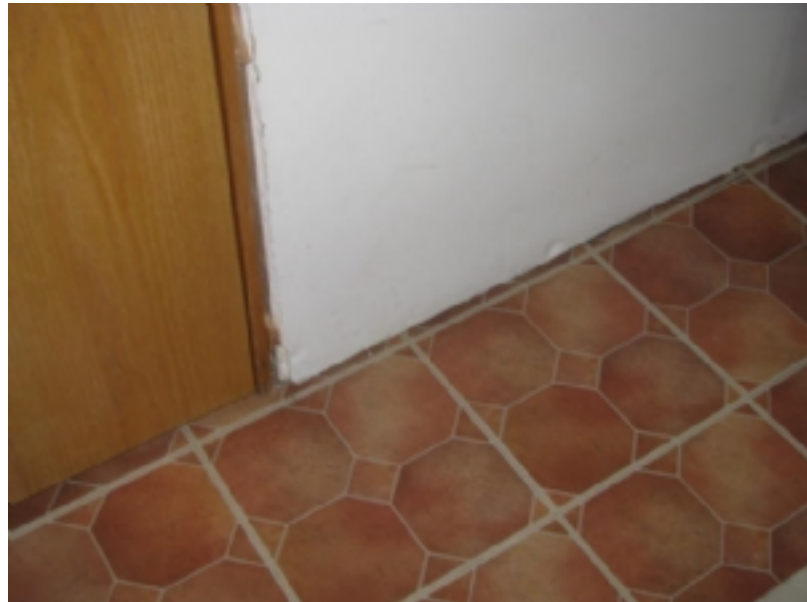
**Exterior Doors:**

**REPAIR or REPLACE** - Damaged sections are present. It is my opinion that these should be fixed before someone gets hurt or additional damage is done to the property. I recommend that you contact a reputable handyman to mitigate this issue. basement door hinge

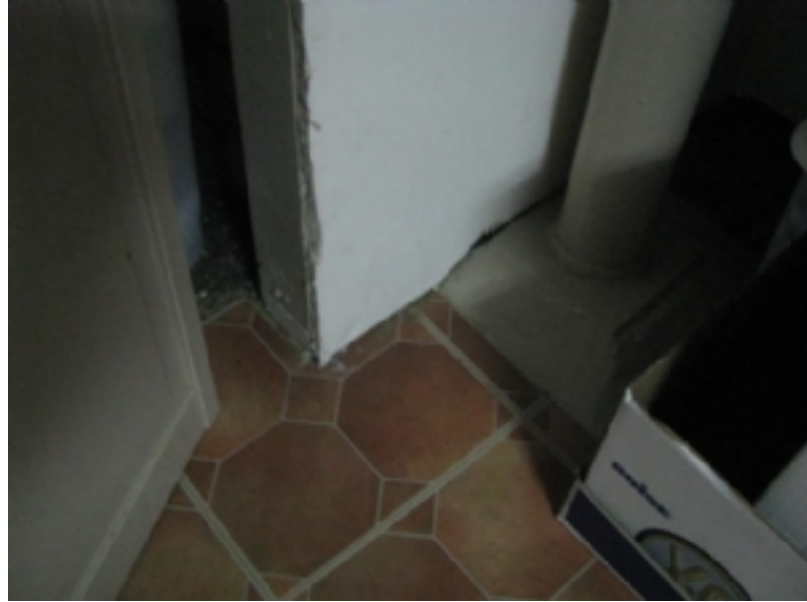
### Interior Doors:

**SAFETY** - There is hardware loose or missing at interior doors. In my opinion this creates daily usage problems and in the event of an emergency can be an entrapment hazard. Repairs recommended by a qualified carpenter.

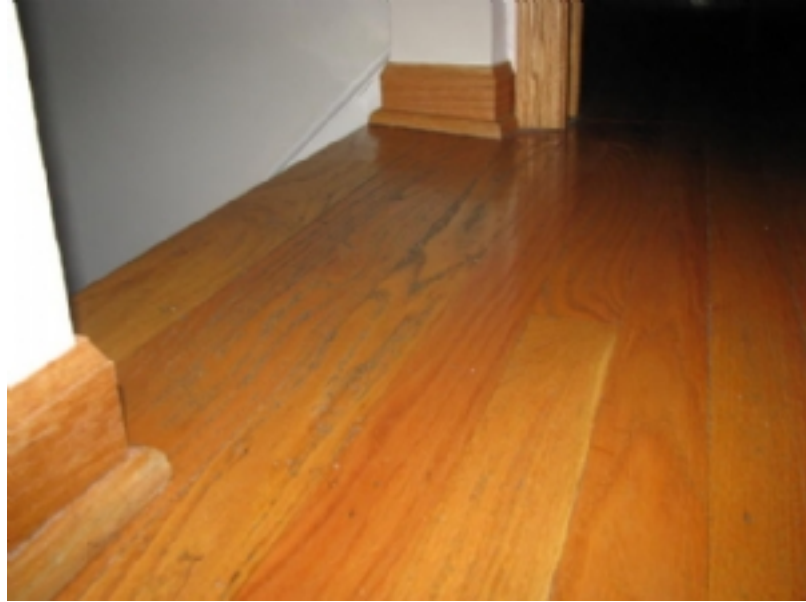
### Staircase:

**SAFETY** - Uneven walking surfaces are present on this property. In my opinion this is considered a trip hazard and can lead to injury if not corrected. I recommend that you contact a qualified contractor to correct this situation. pitcher same as other by mistake
